Survey of overpass foundation in engineering-geological condition of Kazakhstan

Abstract. The aim of the work is to present the results of the inspection of the foundations of the overpass and to determine the causes of the defects. This is a particularly relevant task for countries with a large and extensive territory, such as Kazakhstan. This area is located in the centre of Eurasia, where many international routes between Europe and Asian countries have crossed since ancient times until the present day. One of the main international highways is Yekaterinburg - Almaty (2336 km), which is one of the main transport routes between Russia and Kazakhstan. This road was intensively reconstructed in 2013. An overpass was built on the 1114-1137 km section of the Yekaterinburg - Almaty Road. Unfortunately, there was downtime in the construction process. It is therefore proposed to inspect the foundations of the structures, the subgrade soil before continuing the construction. The overpass is located in the village of Zhaltyr, Akmola region.

DOI: doi.org/10.32523/2616-7263-2023-142-1-116-126

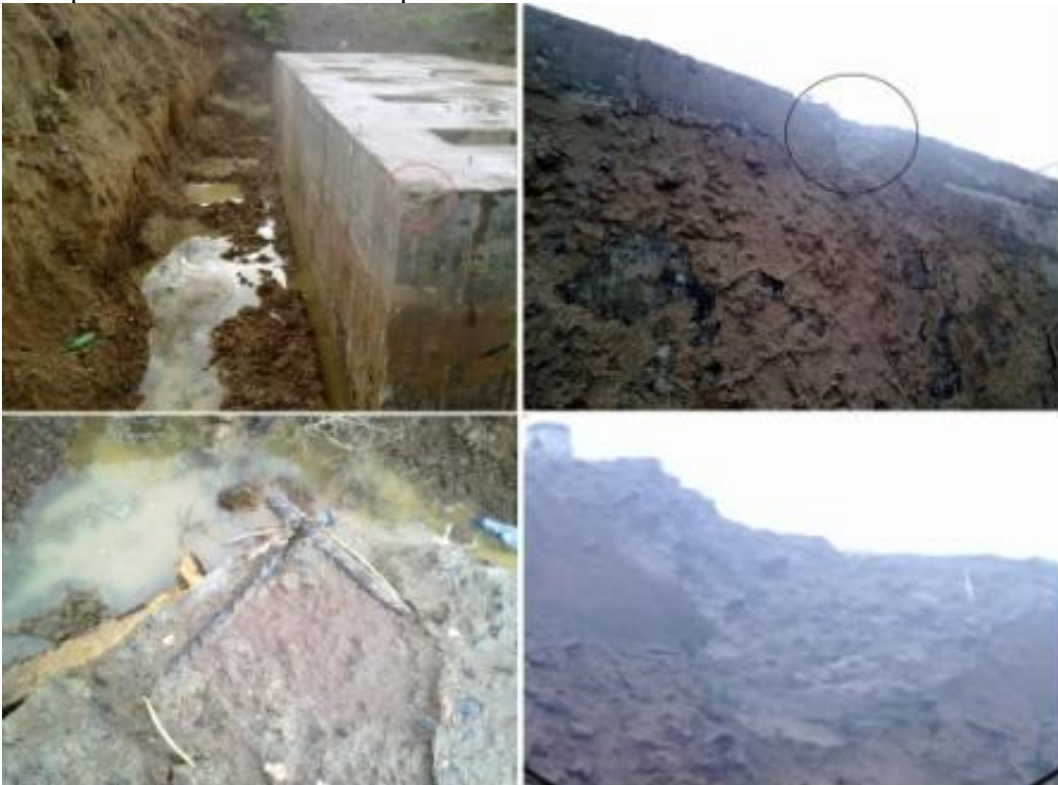
- delamination and spalling on the surface of foundations (Figure 4);
- cracks on the surface of monolithic foundations (figure 5);
- Exposed rebar in foundation pits.

Figure 4. Failure of concrete foundations

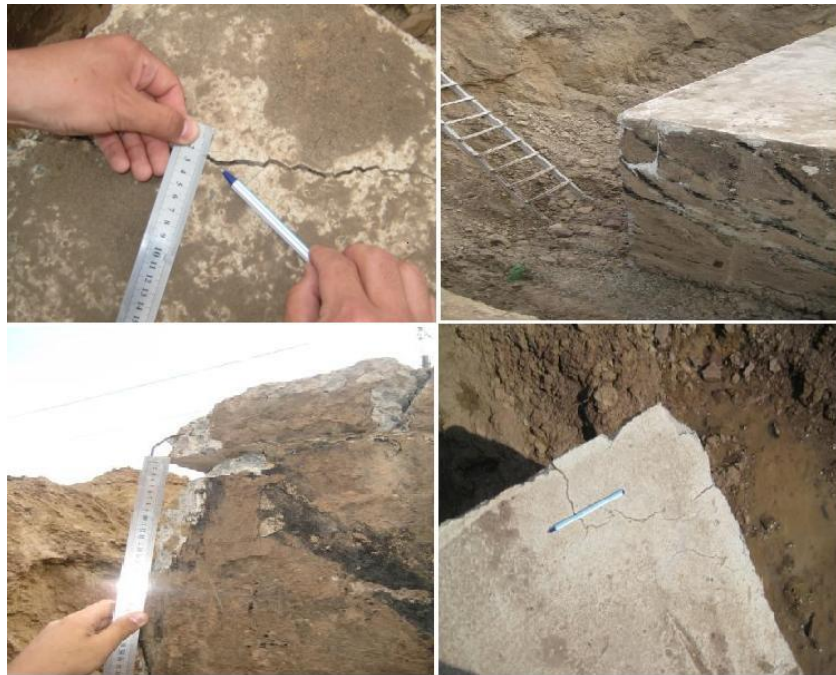
Figure 5. Chips and potholes found on foundations

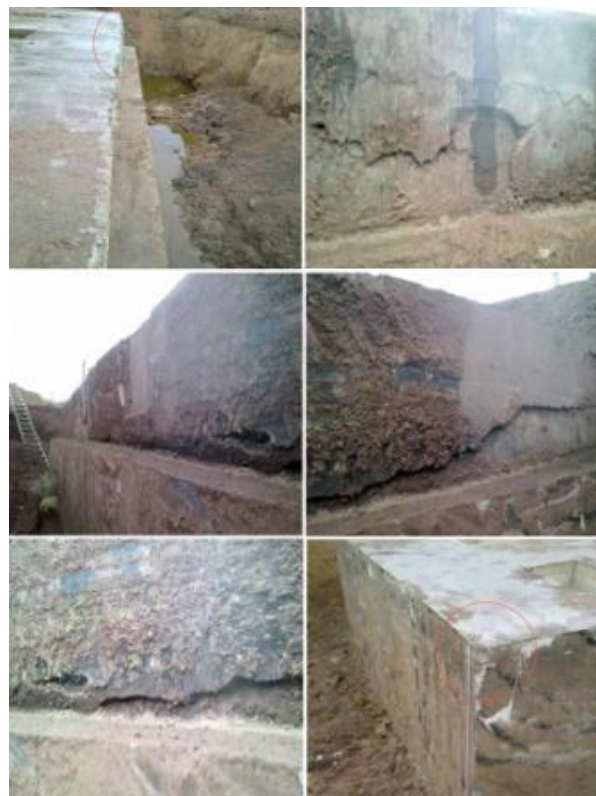
Instrumental inspection of foundations revealed geometric deviations from their design dimensions of MF №3 foundation by 10-12 cm (Figure 6).

Figure 6. Detected defects in foundation structures

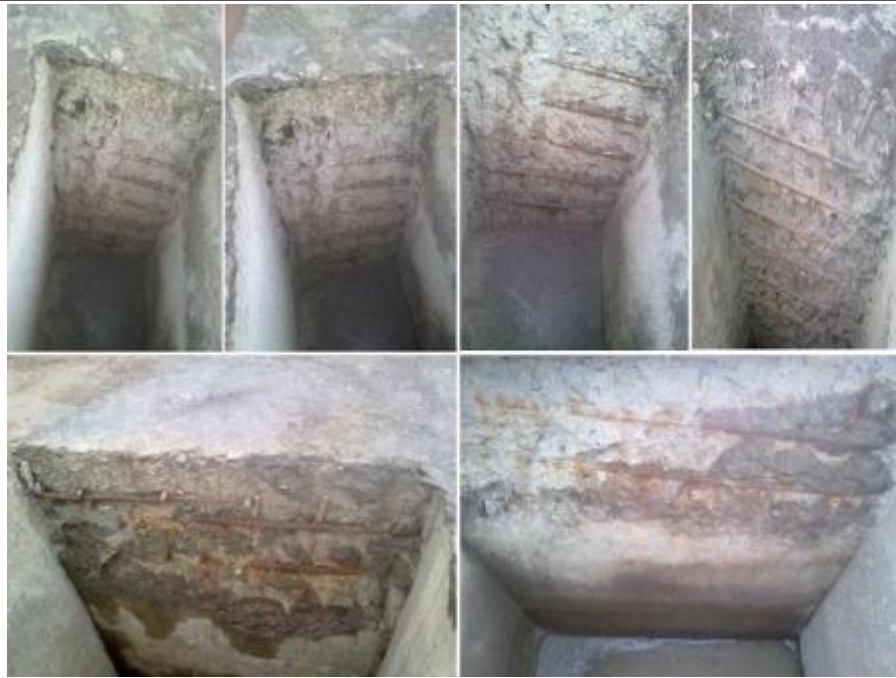
Corrosion of the reinforcement in the foundation wells is shown in Figure 7.

Figure 7. Corrosion of fittings in foundation wells for props

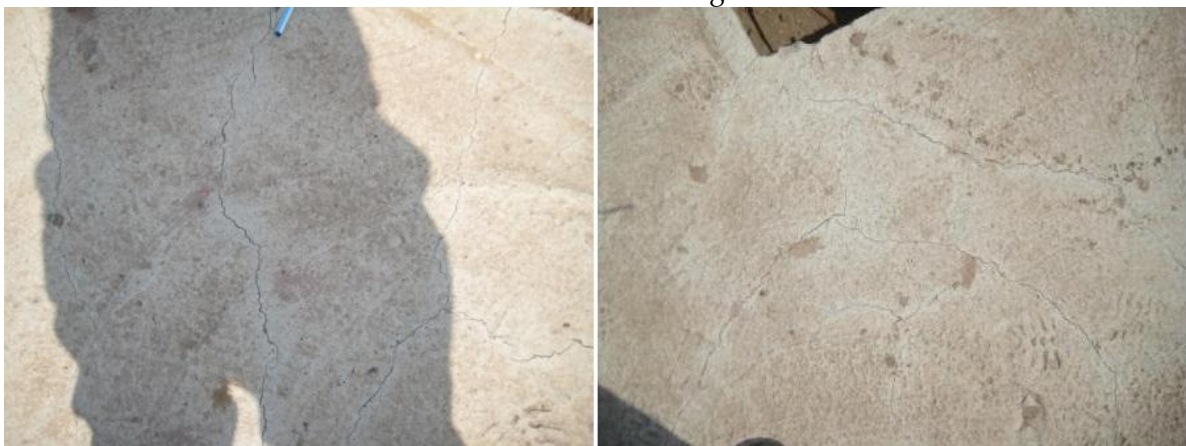
Cracks on the surface of the foundation are shown in Figure 8.

Figure 8. Cracks in the surface of the MF#4 foundation

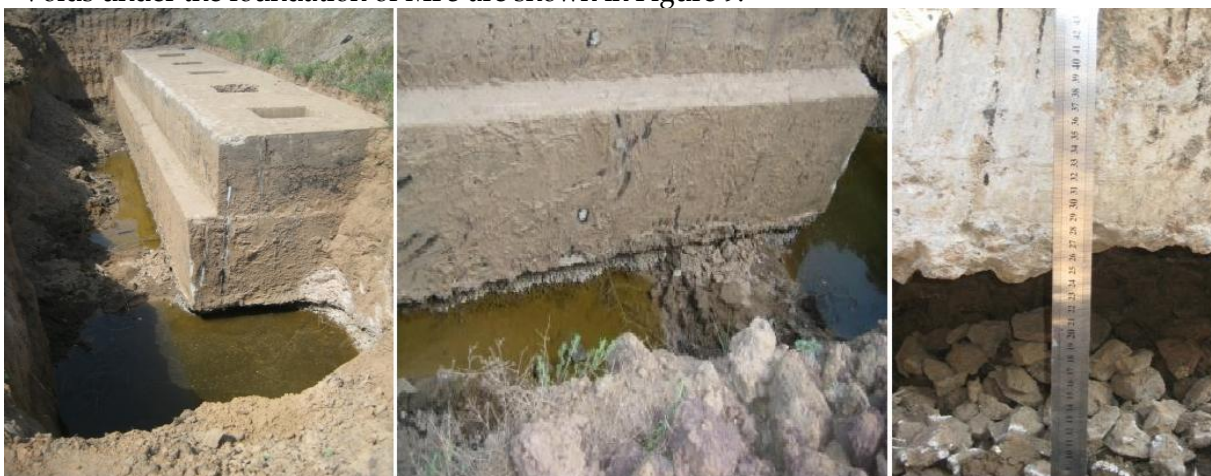
Voids underneath the bottom of the MF#3 foundation are shown in Figure 9.

Figure 9. Voids underneath the bottom of the MF#3 foundation
