## **Earthquake disasters and countermeasures-the case of japan, hachinohe**

**Abstract.** On December 8, 2025, a major earthquake struck off the eastern coast of Aomori Prefecture, causing severe damage in Hachinohe City and surrounding areas. The event highlighted the vulnerability of regional infrastructure, economic activities, and local communities to seismic and tsunami hazards. This study examines the impacts of the earthquake on transportation facilities, communication networks, residential districts, public utilities, and social systems. Using Hachinohe as a representative case study, the paper reviews historical experiences with earthquakes and tsunamis in Japan, the geophysical mechanisms responsible for their occurrence, and the strategies implemented to reduce disaster-related losses. Particular attention is given to the resilience of critical infrastructure, emergency response operations, evacuation procedures, and post-disaster recovery processes. The research also evaluates the effectiveness of existing disaster management policies and community-based preparedness programs. Furthermore, the study discusses potential challenges associated with future environmental a

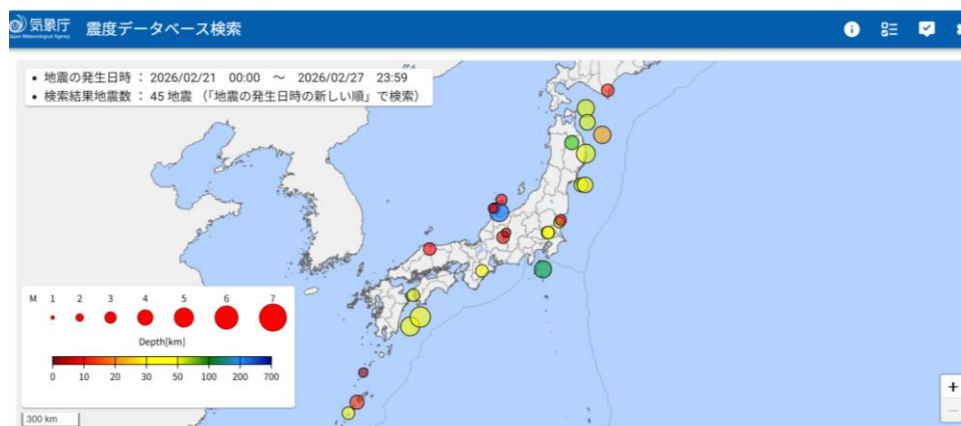
Figure 5 shows earthquakes with a maximum seismic intensity of 1 or higher that occurred during the week from February 21st, plotted with the magnitude as the diameter. 45 earthquakes occurred during this period. This kind of information can be found on the Japan Meteorological Agency's website. The area around Hachinohe City experiences approximately one earthquake per day.

Figure 5. Earthquakes with a seismic intensity of 1 or higher in 24 hours (from Feb. 21, 2026, to Feb. 27, 2026) in Japan. By Japan Meteorological Agency:  
<https://www.data.jma.go.jp/eqdb/data/shindo/index.html>

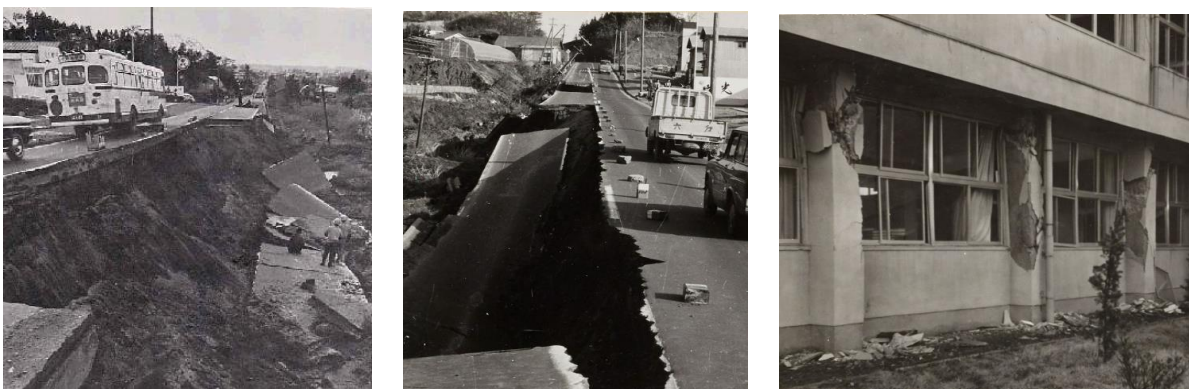
Figure 12 shows the 1968 earthquake, which, due to heavy rainfall in the days leading up to it, resulted in numerous ground-related disasters.

Figure 12. Damage by the 1968 Tokachi offshore Earthquake (Hachinohe City)

Left-Road collapse (Provided by Hachinohe City)

Center-Road collapse (Provided by Disaster Prevention Specialist Library)

Right-Damage to buildings (Provided by Disaster Prevention Specialist Library)

This suggests that earthquake damage can be compounded by other disasters. As mentioned earlier, this earthquake caused significant damage to water pipes, which contributed to Hachinohe

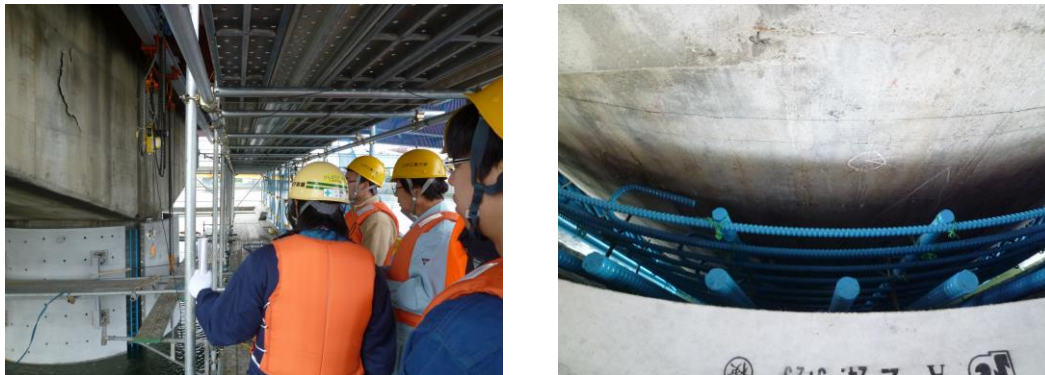
In addition, following the 1994 Sanriku far offshore earthquake, in order to prevent large-scale structural damage in the 1995 Hyogo Prefecture Southern Earthquake that occurred the following month in January 1995, mainly in Kobe City, seismic regulations for various structures were revised and seismic reinforcement work was carried out. For bridges, in addition to seismic reinforcement of bridge piers, the installation of bridge girder collapse prevention devices has been carried out in various places. In Hachinohe City, as shown in Fig.15, seismic reinforcement of bridge piers has also been carried out mainly on important routes.

Figure 15 Seismic reinforcement of bridge piers by PC panels  
(2012, Yanagibashi Bridge, Hachinohe City)

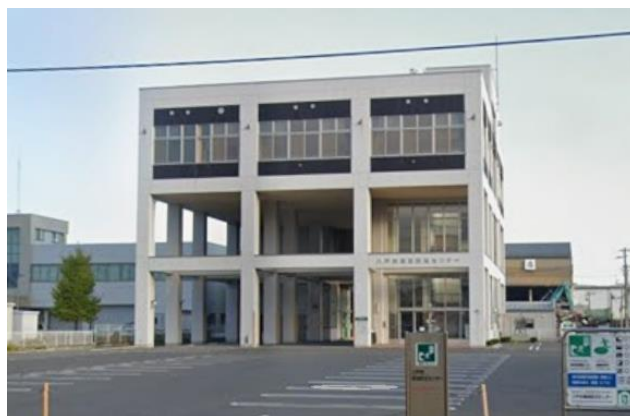
Figure 18 Tsunami Disaster Prevention Center in Hachinohe  
Constructed for tsunami evacuation purposes in a low-lying area with no nearby elevated ground.

These include tall buildings such as elementary and junior high schools, shopping centers, and factories in coastal areas, with cooperation from both public and private facilities. Additionally, these include evacuation towers constructed specifically for tsunami evacuation in low-lying areas without nearby higher ground. Fig. 18 shows one of the tsunami evacuation buildings constructed in response to the tsunami damage caused by the 2011 Tohoku earthquake and tsunami. It is equipped with necessary supplies for evacuation, such as drinking water, food, and heating equipment. It is also sometimes used for disaster prevention meetings.
