## **Earthquake disasters and countermeasures-the case of Japan, Hachinohe**

**Akira Hasegawa**

*Hachinohe Institute of Technology, Hachinohe, Japan*

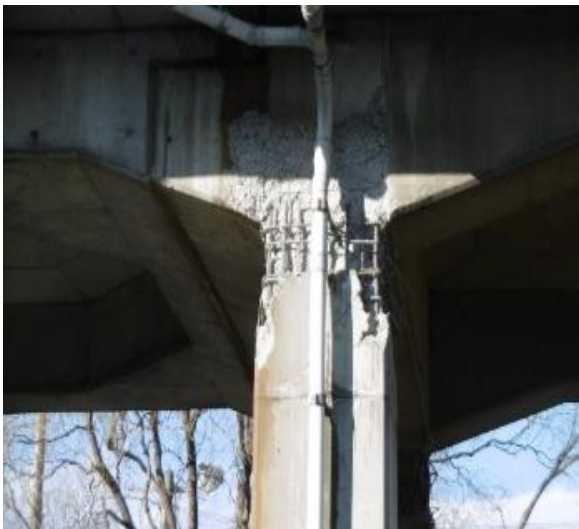
Figure 1. Viaduct pier of Railway in Hachinohe Figure.2. Tower with a broken vertical member

Fig.1 shows the damage to the top of the viaduct piers of the Hachinohe Line railway. Due to this damage, the Hachinohe Line was unusable, but it was restored and operations resumed three weeks after the disaster. Fig.2 shows a communication tower with a fractured vertical member. Because there was a risk of collapse, and concerns about the tower's collapse after the earthquake, surrounding residents evacuated, and surrounding roads became impassable. Repairs were completed 18 days later, the evacuation of surrounding residents ended, and life returned to normal. In the city center and some residential areas, buildings have been damaged and repairs are underway.

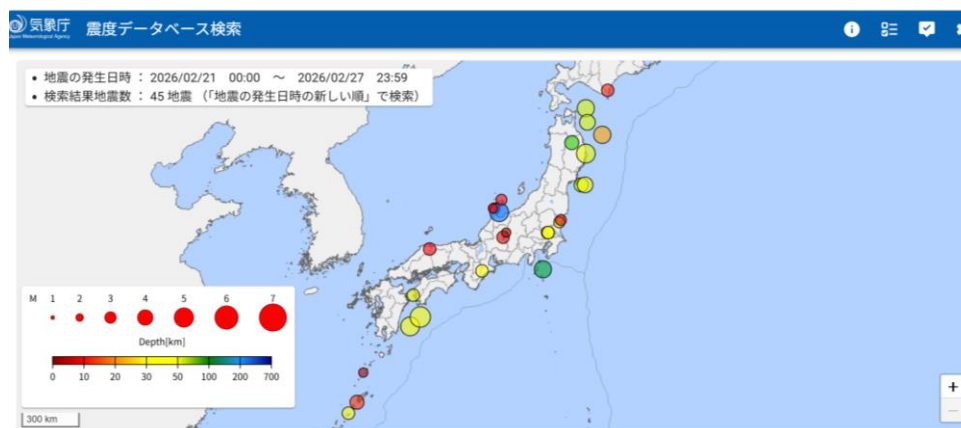
Figure 5 shows earthquakes with a maximum seismic intensity of 1 or higher that occurred during the week from February 21st, plotted with the magnitude as the diameter. 45 earthquakes occurred during this period. This kind of information can be found on the Japan Meteorological Agency's website. The area around Hachinohe City experiences approximately one earthquake per day.

Figure 5. Earthquakes with a seismic intensity of 1 or higher in 24 hours (from Feb. 21, 2026, to Feb. 27, 2026) in Japan. By Japan Meteorological Agency:  
<https://www.data.jma.go.jp/eqdb/data/shindo/index.html>

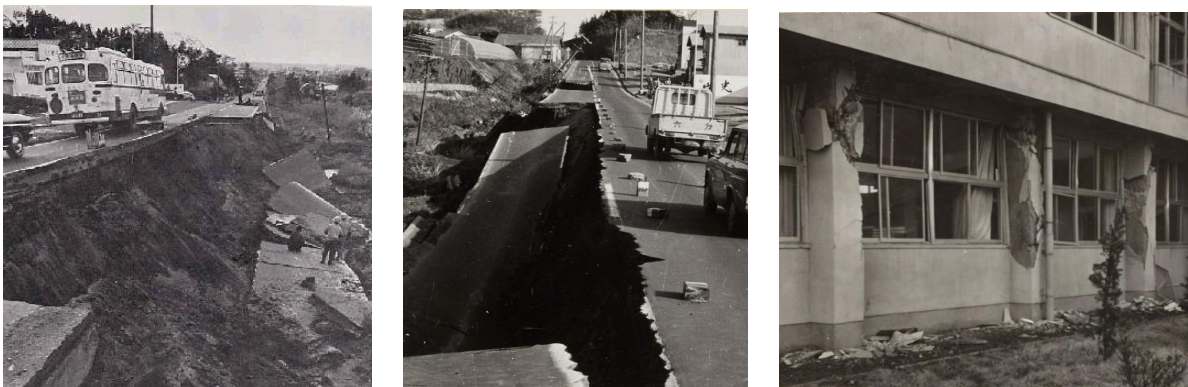
Figure 12 shows the 1968 earthquake, which, due to heavy rainfall in the days leading up to it, resulted in numerous ground-related disasters.

Figure 12. Damage by the 1968 Tokachi offshore Earthquake (Hachinohe City)

Left-Road collapse (Provided by Hachinohe City)

Center-Road collapse (Provided by Disaster Prevention Specialist Library)

Right-Damage to buildings (Provided by Disaster Prevention Specialist Library)

This suggests that earthquake damage can be compounded by other disasters. As mentioned earlier, this earthquake caused significant damage to water pipes, which contributed to Hachinohe

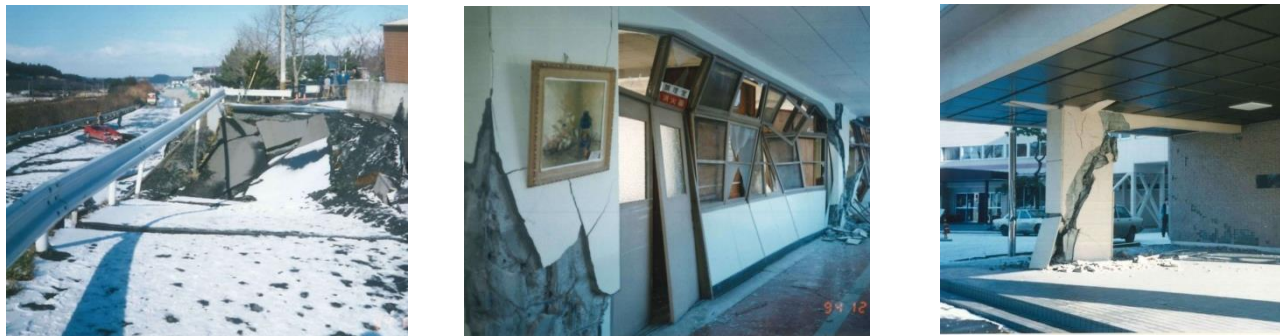
Figure 13 shows the 1994 earthquake, which caused extensive damage to buildings such as the city hall and schools in Hachinohe City. In January of the following year, 1995, the Great Hanshin Earthquake caused significant damage to structures, leading to major changes in earthquake-resistant building standards.

Figure 13. Damage by the 1994 Sanriku far offshore Earthquake (Hachinohe City) Left Slope collapse (from Morioka Meteorological Observatory website), Center) Damage to buildings (ibid.) Right Damage to buildings

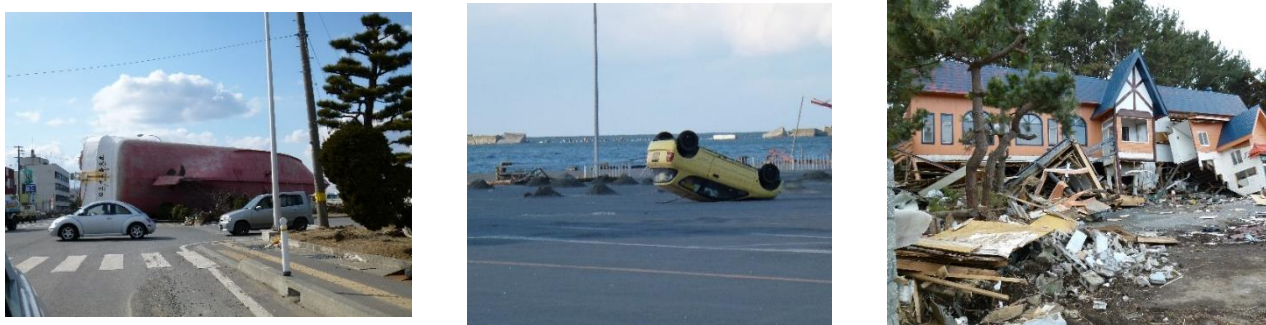
Figure 14 shows the 2011 earthquake, which brought a large tsunami to Hachinohe City. Breakwaters designed to maintain harbor tranquility were destroyed, fishing boats moored in the harbor were washed ashore, and beachfront restaurants were damaged. The height of the tsunami that hit Hachinohe City was lower than that of Iwate and Miyagi prefectures to the south.

Figure 14. Damage by the 2011 Tohoku Region Pacific Ocean offshore Earthquake and Tsunami

(Hachinohe City) Left) Bottom of a fishing boat washed ashore in Hachinohe Port by the tsunami (by author) Center) Overturned car. Offshore breakwater was destroyed in Hachinohe Port. (Ibid.) Right) Damage to a restaurant near the coast (Ibid.)

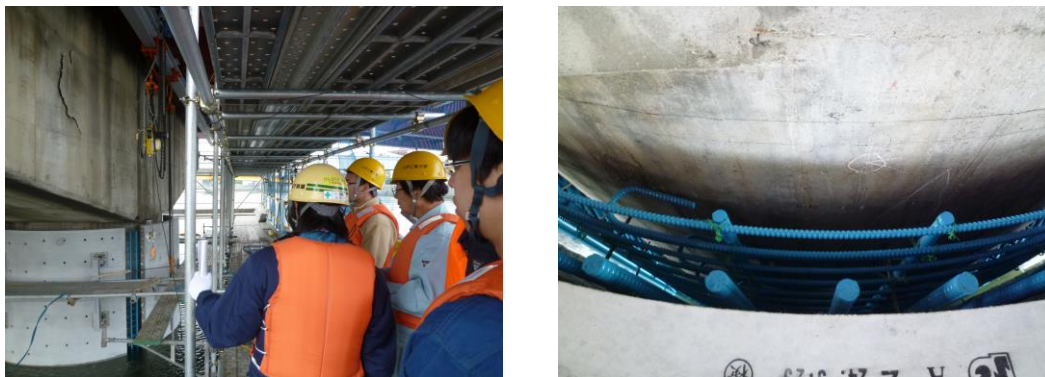
In addition, following the 1994 Sanriku far offshore earthquake, in order to prevent large-scale structural damage in the 1995 Hyogo Prefecture Southern Earthquake that occurred the following month in January 1995, mainly in Kobe City, seismic regulations for various structures were revised and seismic reinforcement work was carried out. For bridges, in addition to seismic reinforcement of bridge piers, the installation of bridge girder collapse prevention devices has been carried out in various places. In Hachinohe City, as shown in Fig.15, seismic reinforcement of bridge piers has also been carried out mainly on important routes.

Figure 15 Seismic reinforcement of bridge piers by PC panels  
(2012, Yanagibashi Bridge, Hachinohe City)

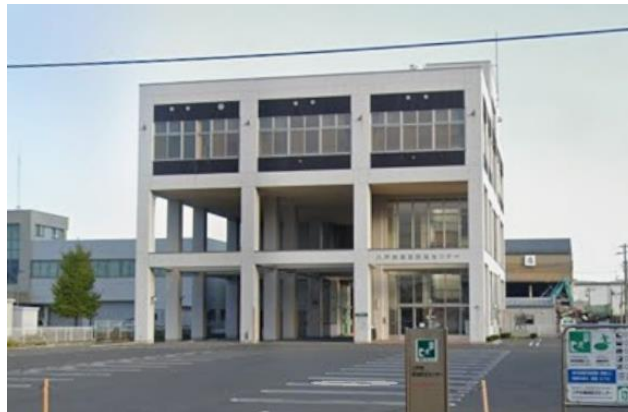
These include tall buildings such as elementary and junior high schools, shopping centers, and factories in coastal areas, with cooperation from both public and private facilities. Additionally, these include evacuation towers constructed specifically for tsunami evacuation in low-lying areas without nearby higher ground. Fig. 18 shows one of the tsunami evacuation buildings constructed in response to the tsunami damage caused by the 2011 Tohoku earthquake and tsunami. It is equipped with necessary supplies for evacuation, such as drinking water, food, and heating equipment. It is also sometimes used for disaster prevention meetings.

Figure 18 Tsunami Disaster Prevention Center in Hachinohe  
Constructed for tsunami evacuation purposes in a low-lying area with no nearby elevated ground.

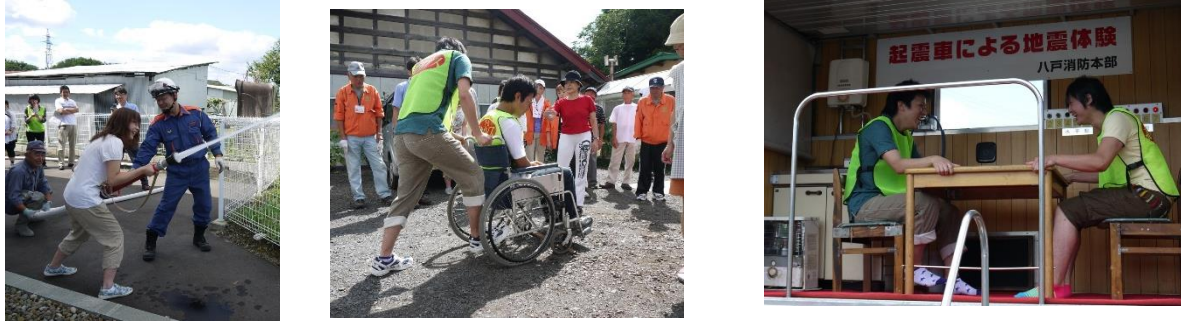
Figure 19. Disaster Prevention Drill (Joint Drill between HIT Students and the Local Community)

- Left Water Discharge Training Conducted Under the Guidance of Firefighters
- Center Training in Evacuation Support for People with Disabilities, Experiencing Evacuation Under Different Conditions (Wheelchair, Slope, Gravel Road)
- Right: Earthquake Experience on a Vibration Table: Earthquake Simulation Vehicle mounted on a Car

choosing September 1st is that this is when Japan enters its windy season, and the country has experienced severe flooding in the past. Fig.19 shows a disaster prevention drill conducted by students of Hachinohe Institute of Technology in collaboration with the local community. It is expected that experiencing these drills will enable people to respond more smoothly in the event of a disaster, thereby reducing damage.
