Survey of overpass foundation in engineering-geological condition of Kazakhstan

Abstract. The aim of the work is to present the results of the inspection of the foundations of the overpass and to determine the causes of the defects. This is a particularly relevant task for countries with a large and extensive territory, such as Kazakhstan. This area is located in the centre of Eurasia, where many international routes between Europe and Asian countries have crossed since ancient times until the present day. One of the main international highways is Yekaterinburg - Almaty (2336 km), which is one of the main transport routes between Russia and Kazakhstan. This road was intensively reconstructed in 2013. An overpass was built on the 1114-1137 km section of the Yekaterinburg - Almaty Road. Unfortunately, there was downtime in the construction process. It is therefore proposed to inspect the foundations of the structures, the subgrade soil before continuing the construction. The overpass is located in the village of Zhaltyr, Akmola region.

DOI: doi.org/10.32523/2616-7263-2023-142-1-116-126

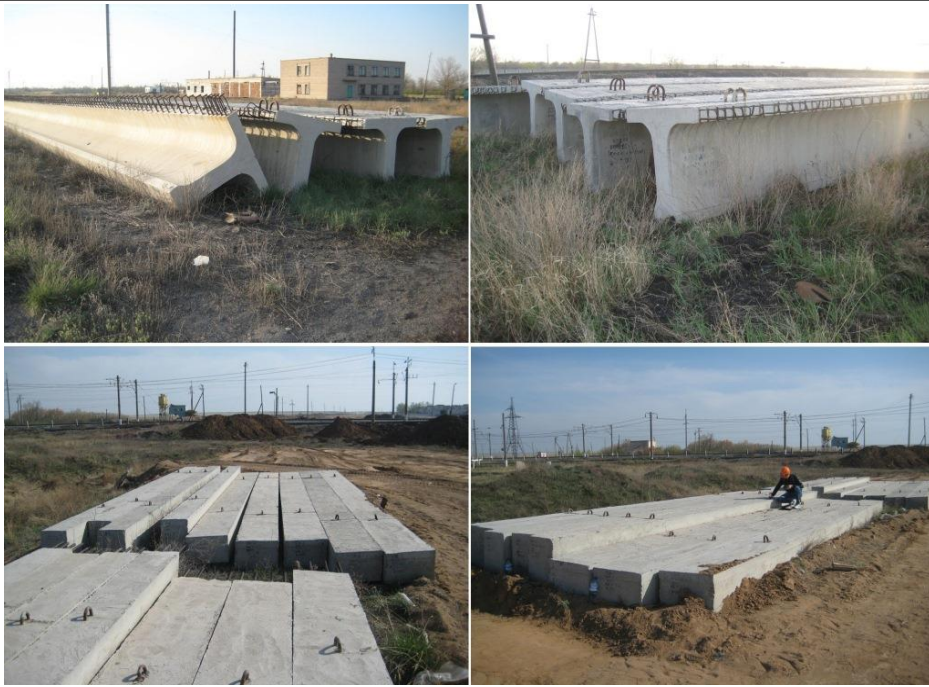
Figure 3. Supports and beams

Supports - reinforced concrete with a section of 40x60 cm on a natural base. The extreme supports of the viaduct are the bulk foundations of the gantry type. Intermediate supports - rack-mount single-row. In the foundation sockets, the stoics are mounted with the incorporation of monolithic concrete (Figure 3).

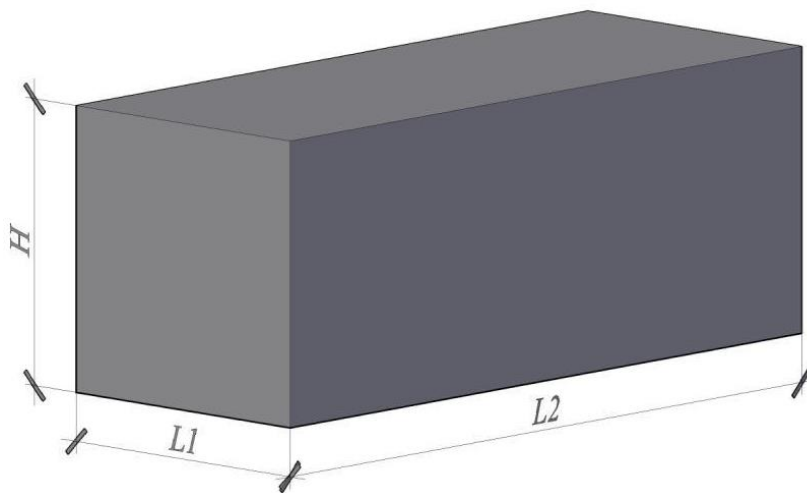
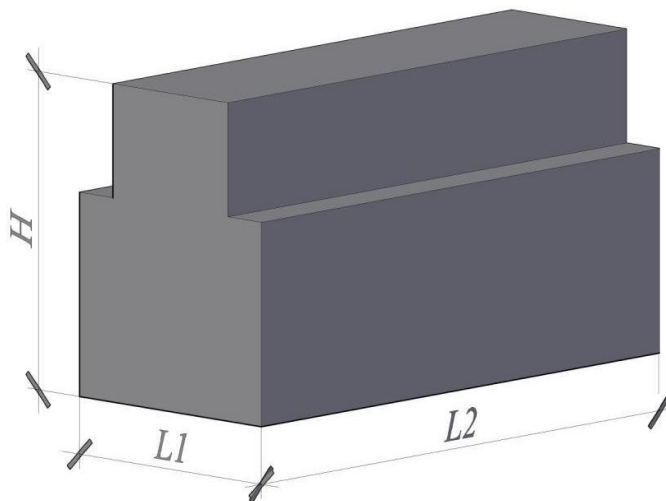
Figure 10. Dimensioning the monolithic foundation along the edges

Determination of actual strength of reinforced concrete monolithic structures conducted by KGS LLP testing laboratory was carried out by non-destructive method, using IPS-MG4 device (electronic concrete strength meter) according to Figure 10.

Фундаменты МФ №1, №4												
L ₁ =5,8м		L ₂ =16м				L ₁ =5,8м		L ₂ =16м				H=2,3м
49	50	51	52	53	54	55	56	57	58	59	60	
37	38	39	40	41	42	43	44	45	46	47	48	
25	26	27	28	29	30	31	32	33	34	35	36	
13	14	15	16	17	18	19	20	21	22	23	24	
1	2	3	4	5	6	7	8	9	10	11	12

Foundations МФ №2, №3							
L ₁ =3,2m		L ₂ =13,8m				H=2,6m	
25	26	27	28	29	30		
19	20	21	22	23	24		
13	14	15	16	17	18

Item brand	Required design strength of concrete		Average actual concrete strength		Safety margin, %
	R _b , MPa	Concrete grade	R _b , MPa	Concrete grade	
Monolithic foundations					
MF#1(1-12)	32,7	B25	32,9	B25	1
MF#1(13-24)	32,7	B25	33,0	B25	1
MF#1(25-36)	32,7	B25	36,0	B27,5	9
MF#1(37-48)	32,7	B25	36,6	B27,5	11
MF#1(49-60)	32,7	B25	42,2	B30	23
TOTAL:					
Average safety margin of MF No. 1					9%
MF#2(1-6)	32,7	B25	36,0	B27,5	9
MF#2(7-12)	32,7	B25	36,4	B27,5	10
MF#2(13-18)	32,7	B25	41,5	B30	21
MF#2(19-24)	32,7	B25	41,1	B30	20
MF#2(25-30)	32,7	B25	36,3	B27,5	10
TOTAL:					
Average safety margin of MF No. 2					14%
MF#3(1-6)	32,7	B25	40,3	B30	19
MF#3(7-12)	32,7	B25	36,0	B27,5	9
MF#3(13-18)	32,7	B25	36,6	B27,5	11
MF#3(19-24)	32,7	B25	29,3	B20	-12
MF#3(25-30)	32,7	B25	36,5	B27,5	10
TOTAL:					
Average safety margin of MF No. 3					7,4%
MF#4(1-12)	32,7	B25	41,5	B30	21
MF#4(13-24)	32,7	B25	41,4	B30	21
MF#4(25-36)	32,7	B25	42,5	B30	23

which indicates that the concrete of the monolithic foundations has sufficient strength.

The actual concrete strength of the monolithic foundations corresponds to the design strength.
