**TECHNICAL SCIENCES AND TECHNOLOGY** Series

## Overview of Aseismic Design of Subway System against Hidden Fault in Osaka and Damages by Kobe Earthquake in terms of Almaty Subway

**Abstract.** *Fault may cause not only ground motion but also ruptures and displacement of ground surface where various important lifeline systems have been installed. In Almaty, the largest city in Kazakhstan, many hidden faults are shown in microzonation map for earthquake damage. The Kobe Earthquake of 1995 showed damage of subway system due to severe ground motion. Osaka, Japan, has also hidden fault just beneath the downtown of the city. Recent subway construction in Osaka adapted a design procedure against the fault movement. This paper shows the damage of subway in Kobe during the Kobe Earthquake and describes the fault and geotechnical condition of Osaka with the adopted design as well as basic characteristics of the hidden faults in Almaty known to the authors.*

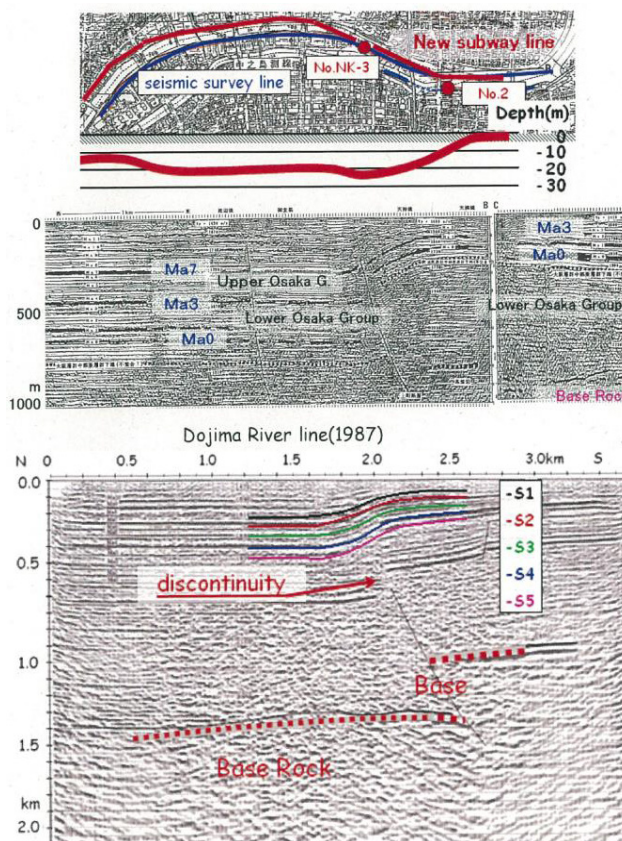
Figure 3 Seismic Reflection Study and Results along the South Bank of River Okawa: Hidden Uemachi Reverse Fault and Flexure Structure above the Fault.

**Seismic Reflection and Geological Studies for the Fault.** The active Uemachi fault (Figure 2) had been long recognized along the western edge of Uemachi Upland by topographical feature. In 1980, a seismic reflection study was carried out along a riverbank of the river Okawa in West-East direction and the result is shown in Figure 3. The Uemachi fault was identified under a flat surface ground condition, as hidden fault. Continuous deformation known as flexure structure near the surface is strongly related to the fault.

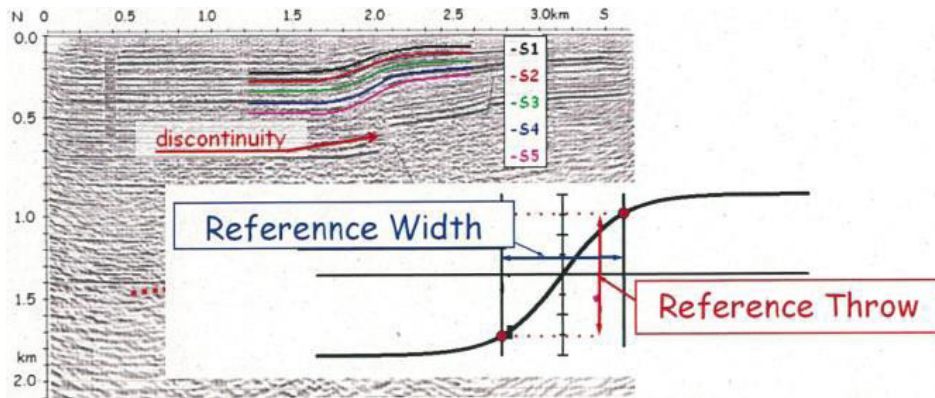
Figure 5 Characteristics of Flexure.

**Flexure Deformation Due to the Uemachi Fault.** Seismic reflection surveys give us clear characteristics of flexure deformation caused by the hidden fault in Osaka. The fault deformation can be characterized by a hyperbolic tangent curve normalized by maximum throw in vertical axis and by the reference width in horizontal axis (see Figure 5). Example is plotted in Figure 6, where two cases of flexures are shown. Hyperbolic tangent curve is used to search the best fit with seismic as well as boring data to obtain the deformation curve for Ma6 layer of Uemachi Flexure. Deformation curve and radius of curvature of Ma6 layer, estimated from these data, are further used to estimate by FEM modelling the reference width and dip angle of the fault. The reference width was obtained as 300m and dip angle is 60 degrees towards East. Figure 7 shows example of FEM numerical simulation of flexure for a set of physical parameters of ground estimated in boreholes. Linear constitutive law was assumed in this case.

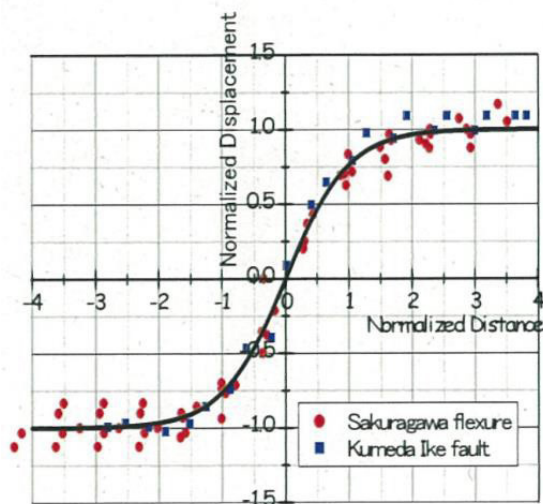
Figure 6 Normalized Flexure Deformation.

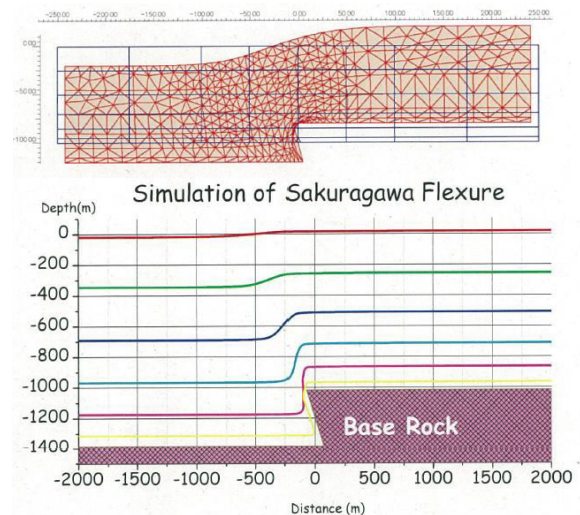
Figure 7 Example of Numerical Simulation of Uemachi Fault Flexure.

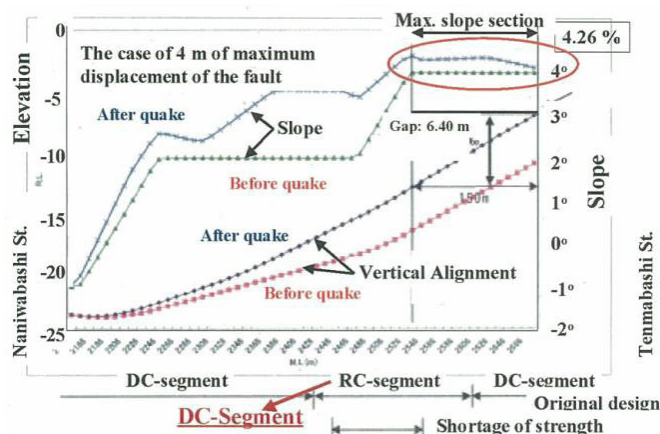
Figure 8 Subway Vertical Alignments Before and After Fault Displacement of 4 m

**Expected Behavior of Shield Tunnel due to the Fault Displacement.** Based upon the study of several cases with different fault displacements and their effect, it was concluded that two types of emergency plan for the countermeasure should be prepared against two different magnitudes of fault displacements. As shown in Figure 8, in one of the section of the subway, the vertical alignment

had to be designed using steep inclination of 4% so as to run under the riverbed with enough cover to keep the safe tunnel construction. The inclination value 4% is the allowable maximum value for train operation in Japan. Whenever the next Uemachi fault displacement shall cause the same amount of deformation for the Uemachi flexure as in the past earthquake, the maximum inclination of the subway exceeds the critical value of 4% and the railway operation shall be forced to terminate.

At any rate, the section of the shield tunnel of 700 m was assigned as affected by the fault displacement. Among various considerable countermeasures to avoid damage of the shield tunnel, it was decided to adapt the ring segments made by ductile steel (DC) rather than precast reinforced concrete (RC) as given in Figures 8 and 9. The moment strength of DC is about 2.5 times larger than that of RC.

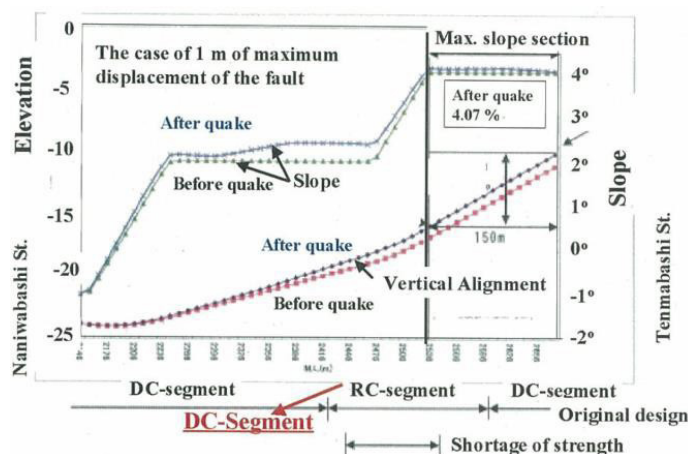
Figure 9 Subway Vertical Alignments Before and After Fault Displacement of 1 m

However, if the fault displacement is some value less than 4m, the railway vertical alignment can be adjusted to keep the inclination less than 4% if tunnel inner cross-section has set up some room. For instance, if tunnel inner cross section is widened about 10cm vertically and the fault displacement is less than 1m, it can adjust the inclination within the allowable value as shown in Figure 9 and the railway to continue its service even after the earthquake.

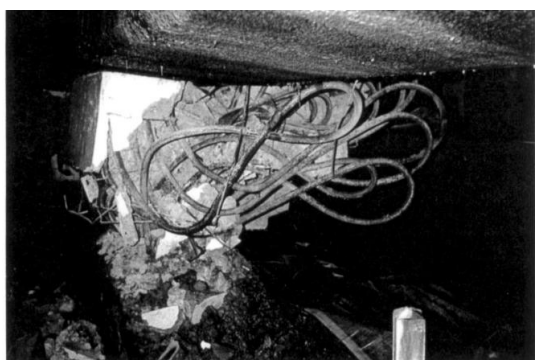
Photo 1 Collapse of no. 10 column in Zone A.

Damage was the most severe at zone A, in the Nagata side zone. Almost all of the center columns completely collapsed and the ceiling slab fell down. As a result, the original box frame structure was distorted to an M-shaped section as shown in Figure 11(a). Typical damage to the center columns is shown in Photo 1. The ceiling slab kinks and cracks 150 to 250 mm wide appeared in the longitudinal direction about 2.15 to 2.40 m from the center line of the columns. In addition, the separation of cover concrete was observed over almost the entire area near the haunch and the intersection between the lateral wall and ceiling slab. In zone B, as shown in Figure 11(b), the collapse of the column occurred in the upper portion and reinforcing steel buckled into a symmetrical shape for columns 24 and 25. The upper longitudinal beam connecting the center columns was bent at a point between columns 25 and 26. The small separation of the corner concrete of the center columns is observed at the mountain side of upper portion and at sea side of lower portion, in columns 26, 27 and 28.

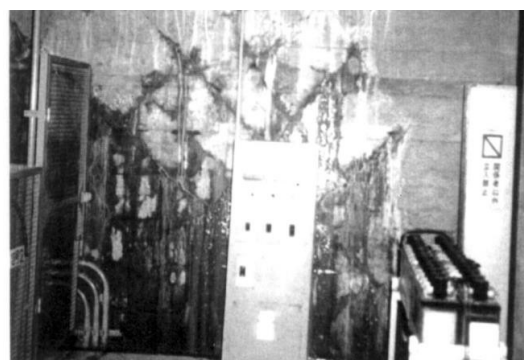
Photo 2 Cracks in the transverse wall in electric facility room.

In the lateral wall, separation of cover concrete was observed near both of the top and the bottom haunches. According to the investigation of the exterior surface, wide cracks in the longitudinal direction were observed along the intersection with the haunch. Under the platform, a significant separation of cover concrete was observed on the both side lateral walls. There are several walls in the transverse direction: both of the ends, electric facility room, switching station room, etc. Diagonal cracks typically shown in Figure 11(d) and Photo 2 were observed in all the walls in the transverse direction.

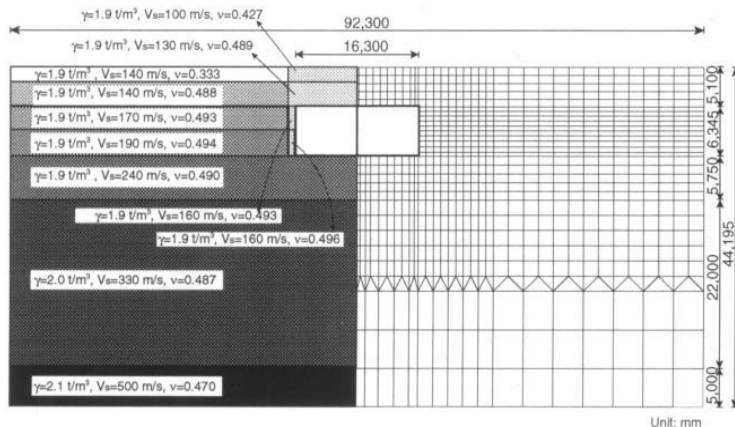
Figure 12 Soil-structure system used in the dynamic response analysis.

Soil-structure model used in the first step analysis is shown in Figure 12. Energy transmitting boundary and viscous boundary are used along the lateral and base boundaries, respectively. Structural members are modeled to elastic beam elements considering rigid zone. The rigidity of each member is evaluated by considered the property of both concrete and reinforced bar.
